Manhole Inspection Summary

Manhole # S63G__008MH

Insp Date: **3/26/08 9:03 AM**

Location Address: **5100 Bayview Blvd.**

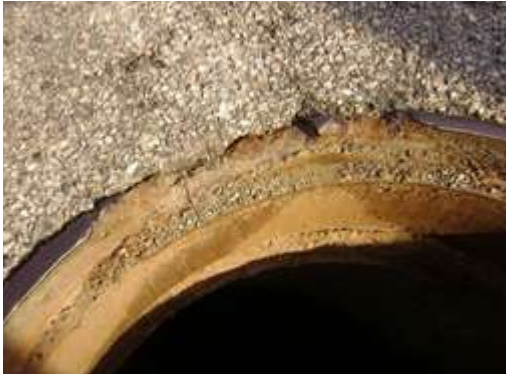
Defect 2

crack in frame

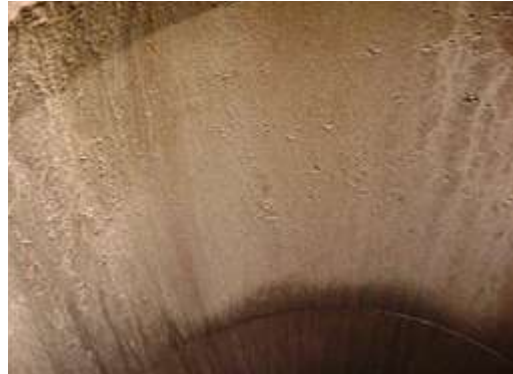
Defect 3

Infiltration: ☐ None ☒ **Joint** ☐ Cracks ☐ Mortar ☐ Roots ☒ **Wall**

INFILTRATION AT PRECAST SECTION JOINT

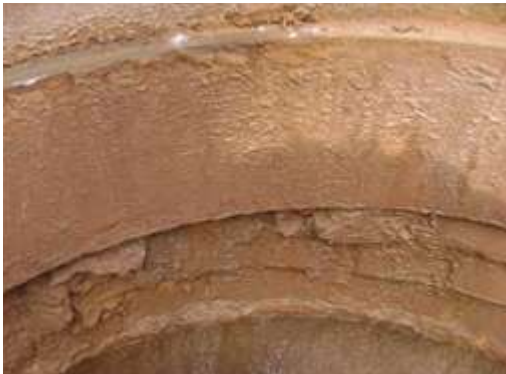
Defect 4

EVID OF INFILTRATION UNDER FRAME SEAL

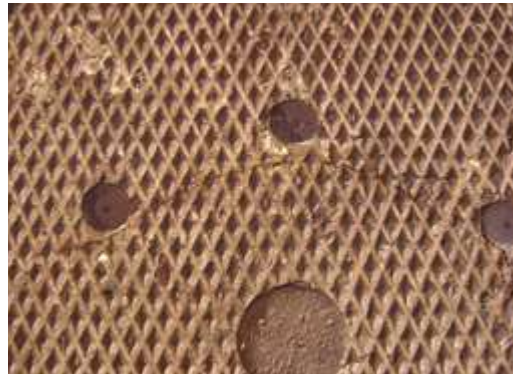
Defect 1

Condition: **Cracked**

crack in manhole cover.

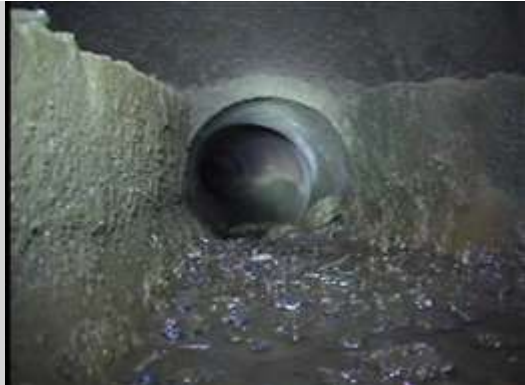
12 O'Clock Outflow

Pipe Height: **8.4** (in.) Rod and Bar (Angled)
Pipe Material: **Clay** ☐ Pipe Lined
Invert Depth: **17.42** (ft.) Flow Characteristics: **None**
Deposits: ☐ None ☐ Mud ☒ **Sludge** ☐ Debris ☐ Grease
Silt Depth: **0.5** (in.) Deposits Extent: **Light**
Infiltration: **None** Pipe Seal Cond: **Sound**
